Asset Management and Performance of Information System- Based Irrigation System

Azis Hartanto, S. Imam Wahyudi, Soedarsono

Universitas Islam Sultan Agung Semarang, Indonesia

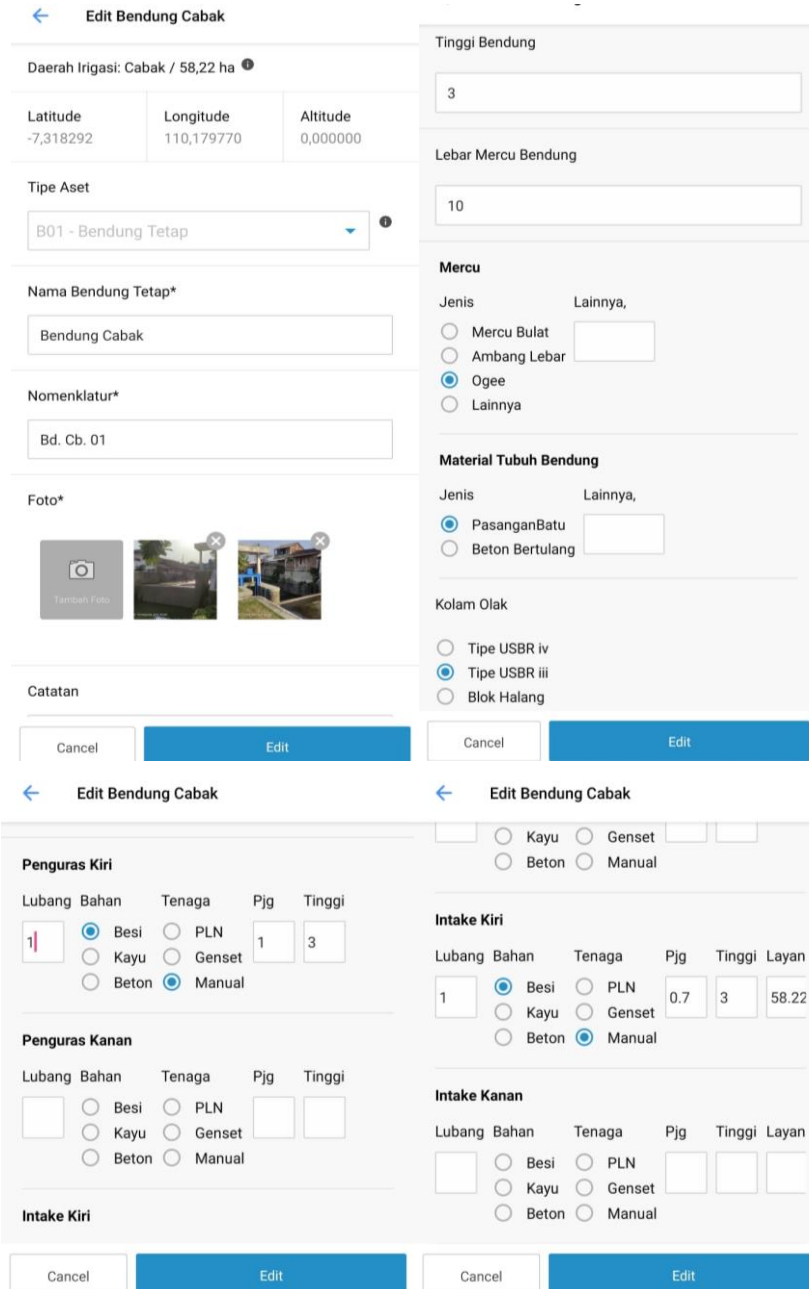
Figure 2. Input PAI Data on Retrieval Building Assets

Examples of data input and analysis of irrigation assets in retrieval building assets using the ePAKSI android application include:

- a. Asset type = fixed weir
- b. Weir name = Cabak weir
- c. Nomenclature = Bd. Cb. 01
- d. Weir height = 3 m
- e. Weir width = 10 m
- f. Mercu type = Ogee
- g. Weir body material = masonry
- h. Olak pool type = USBR type iii
- i. Number of left drain holes = 1 piece
- j. Left drain door material = iron
- k. Power used on drain door = manual
- l. Length of drain door = 1 m
- m. Dewatering door height = 3 m
- n. Number of left intake door holes = 1 piece

- o. Left intake door material = iron
- p. Power used on the left intake door = manual
- q. Left intake door length = 0.7 m
- r. Left intake door height = 3 m
- s. Service area = 58.22 Ha
- t. Water discharge = 0.075 m³/s

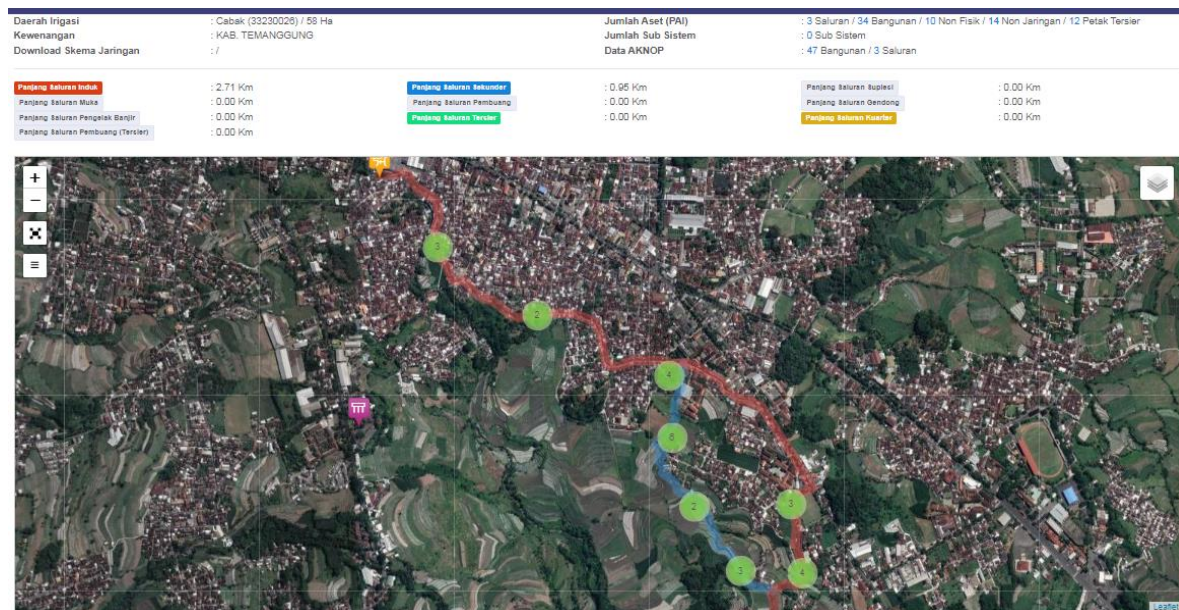
Figure 3. Results of Input and Analysis of Irrigation Asset Inventory Survey Data

Based on the results of input and analysis of ePAKSI data for the inventory survey of irrigation assets in the Cabak Irrigation Area, it is known that the number of assets for the current Cabak Irrigation Area consists of 3 channels, 34 buildings and 14 tertiary plots. Details for the 3 channels consist of 2 primary channels (primary channel 01 length 1,366 m and primary channel 02 length 1,348 m) and 1 secondary channel length 955 m. Of the 34 buildings consisting of 1 fixed weir building, 4 culvert buildings, 9 waterfall buildings, 1 side spillway building, 14 oncoran buildings, 1 UPTD office building, 1 UPTD warehouse building, 1 tapping building, 1 meeting building and 1 end of the channel.
