Engineering-Based Waterfront Redevelopment of Cipondoh Lake in 2022: An Adaptive Construction Approach for Urban Water Bodies

The 2022 redevelopment of Situ Cipondoh represents an engineering-based waterfront intervention aimed at improving public space quality, socio-economic functions, and environmental conditions within an urban water body. This study documents and analyzes the technical implementation of adaptive construction methods in shallow-water environments, contributing to the body of knowledge on sustainable waterfront infrastructure development in densely populated urban areas. The project focused on the arrangement of key waterfront areas, construction of a flying-deck jogging track, development of a floating market for vendor relocation, and light water normalization. This paper applies a descriptive-analytical approach using construction documentation from 2022, supported by field observations, technical specifications analysis, and post-construction evaluation to assess the effectiveness of the engineering solutions implemented. The results show that the application of a flying-deck structure supported by mini piles installed from a pontoon constitutes an adaptive

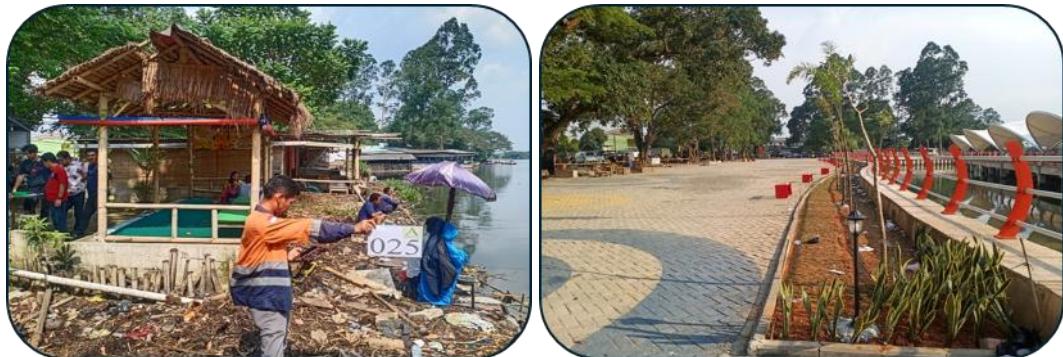
Figure 4. Photos of the condition before and after the arrangement on Spot A

1. Arrangement of Spot A and Spot B: A plaza of 4,142 m² and a 1,908 m² park were formed that were neat and free of illegal buildings. Post-construction monitoring revealed a 78% increase in visitor utilization compared to pre-intervention levels, with peak usage during evenings (18:00-20:00) and weekends. The provision of 32 benches, 8 gazebos, and 45 lighting fixtures enhanced user comfort and safety. Tree planting (85 units of *Tabebuia* sp., *Pterocarpus indicus*, and *Terminalia catappa*) improved microclimate and aesthetic value. Accessibility features including wheelchair ramps (gradient 1:12) and tactile paving for visually impaired users were successfully integrated, making the space inclusive for diverse user groups.

Work methods include *land clearing* of illegal buildings, earthworks (*grading*), and civil works (paving) to transform slums into open plazas. Provision of landscape elements that support social interaction. The work was carried out taking into account accessibility, user comfort and the aesthetics of the open space.
